Inspection Report

Property Address:
123 Nice Street
Asheville, NC 28801

HomeBuyers Inspection HBI

Date: 12/9/2005	Time: 10:09 AM	Report ID: sample1
Property: 123 Nice Street Asheville, NC 28801	Customer: Cameron Spears	Real Estate Professional: Steffan Buchanan Buck Realty

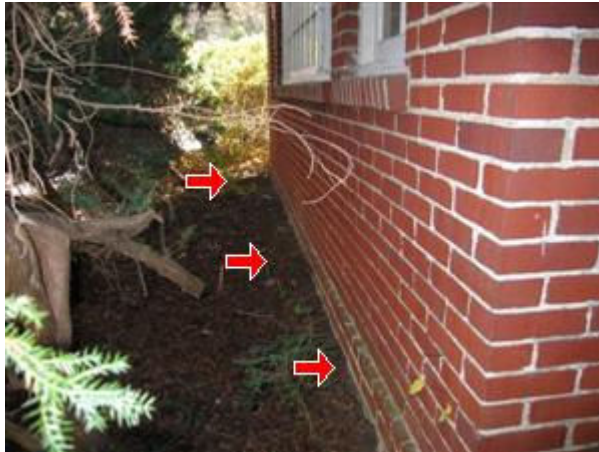
2.0 Picture 1

The Brick siding at the left side (facing front) is loose, and missing mortar. Further deterioration can occur if not corrected. A qualified contractor should inspect and repair as needed.

The Brick siding at the left side (facing front) is loose, and missing mortar. Further deterioration can occur if not corrected. A qualified contractor should inspect and repair as needed.

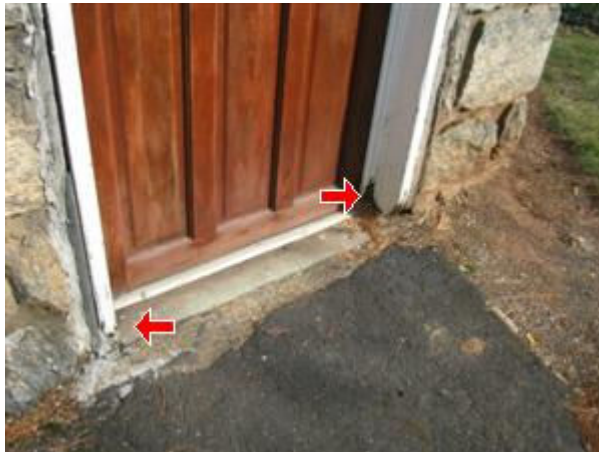
2.1 Picture 1

The main entry door at rear of home are deteriorated at bottom of jamb (s). Further deterioration may occur if not repaired. A qualified contractor should inspect and repair as needed.

The main entry door at rear of home are deteriorated at bottom of jamb (s). Further deterioration may occur if not repaired. A qualified contractor should inspect and repair as needed.

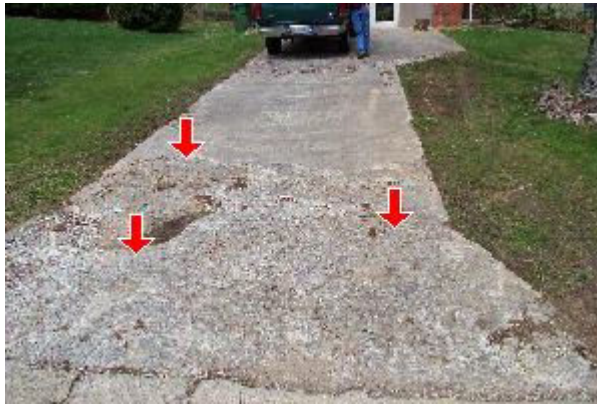
2.4 Picture 1

The concrete drive at the front of home are deteriorated in areas. A general replacement is likely. A qualified contractor should inspect and repair as needed.

The concrete drive at the front of home are deteriorated in areas. A general replacement is likely. A qualified contractor should inspect and repair as needed.

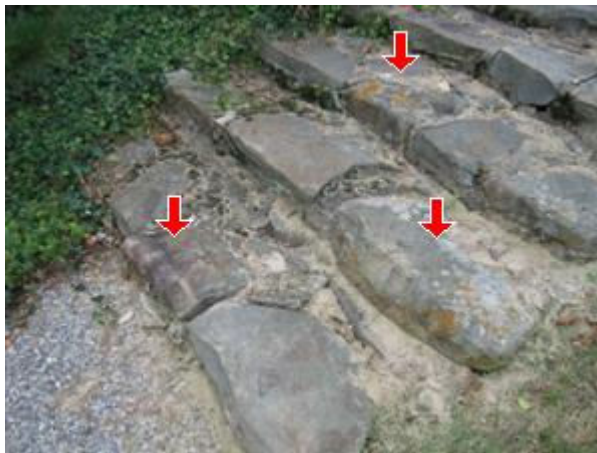
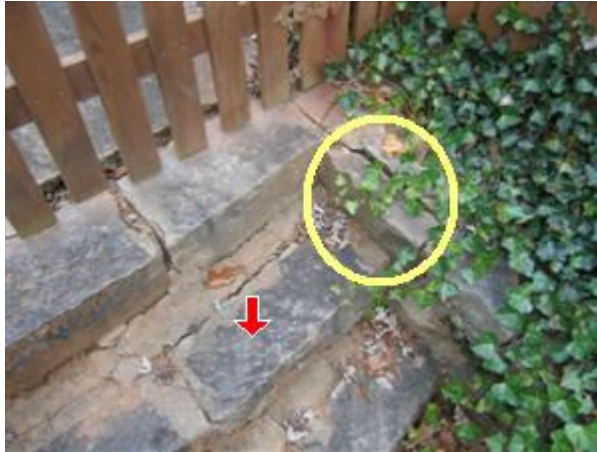
2.4 Picture 2

The rock steps at the front of home and rear of home are loose in areas. Water can cause further deterioration if not repaired and sealed properly. A qualified contractor should inspect and repair as needed.

The rock steps at the front of home and rear of home are loose in areas. Water can cause further deterioration if not repaired and sealed properly. A qualified contractor should inspect and repair as needed.

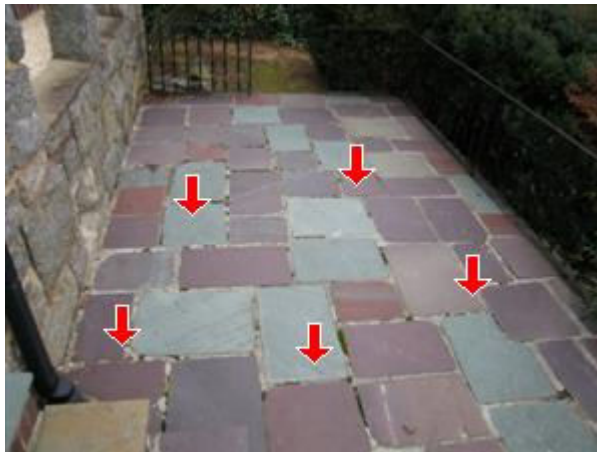
2.4 Picture 4

The slate floor on the patio at the front of home has deteriorated mortar or grout, and is loose and uneven in areas. A general replacement is likely. A qualified contractor should inspect and repair as needed.

The slate floor on the patio at the front of home has deteriorated mortar or grout, and is loose and uneven in areas. A general replacement is likely. A qualified contractor should inspect and repair as needed.

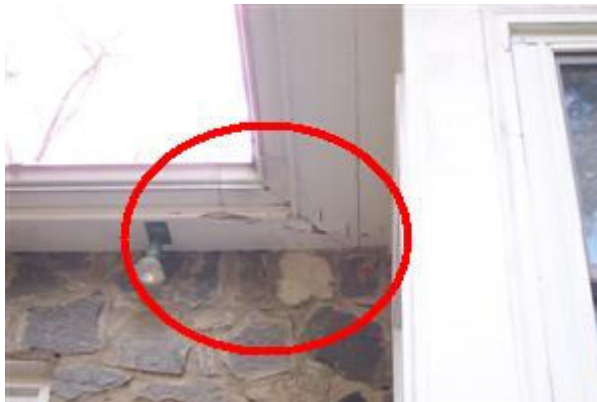
2.5 Picture 1

The soffit panel at eave on the front of home are weathered and beginning to deteriorate and peeling paint. Further deterioration may occur if not repaired. A qualified contractor should inspect and repair as needed.

The soffit panel at eave on the front of home are weathered and beginning to deteriorate and peeling paint. Further deterioration may occur if not repaired. A qualified contractor should inspect and repair as needed.

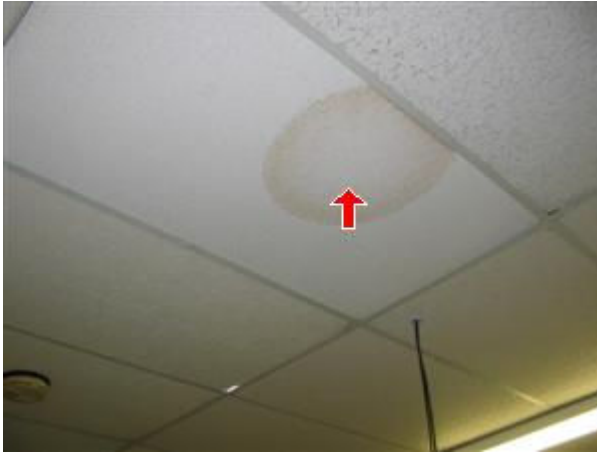
4.0 Picture 1

The Ceiling Tile on the ceiling reveals a water stain indicating a leak did or still exists at the Kitchen. Repairs are needed. A qualified contractor should inspect and repair as needed.

The Ceiling Tile on the ceiling reveals a water stain indicating a leak did or still exists at the Kitchen. Repairs are needed. A qualified contractor should inspect and repair as needed.

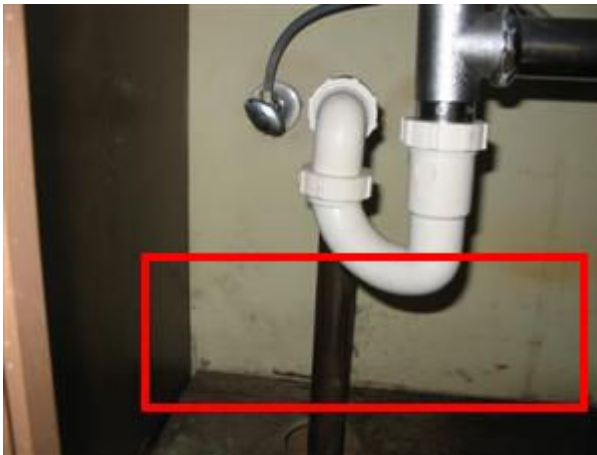
4.1 Picture 1

Signs of fungi growth is present on the interior wall of kitchen cabinetry in several areas. We did not inspect, test or determine if this growth is or is not a health hazard. The underlying cause is moisture. I recommend you contact a mold inspector or expert for investigation or correction if needed.

Signs of fungi growth is present on the interior wall of kitchen cabinetry in several areas. We did not inspect, test or determine if this growth is or is not a health hazard. The underlying cause is moisture. I recommend you contact a mold inspector or expert for investigation or correction if needed.

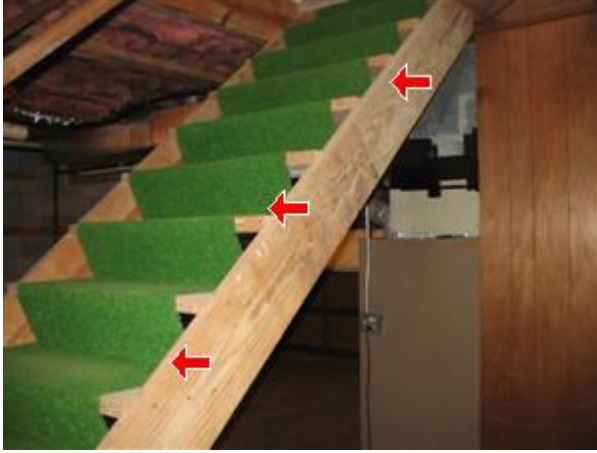
4.3 Picture 1

The hand/guard rail for the stairs to basement is missing and are missing pickets. Also the stringers are not built properly and treads are not supported properly. A fall or injury could occur if not corrected. A qualified contractor should repair or replace as needed.

The hand/guard rail for the stairs to basement is missing and are missing pickets. Also the stringers are not built properly and treads are not supported properly. A fall or injury could occur if not corrected. A qualified contractor should repair or replace as needed.

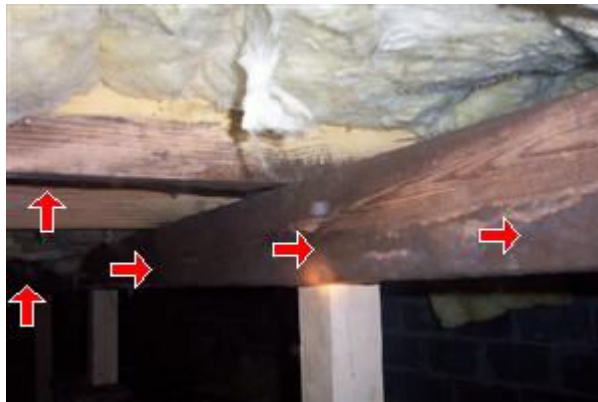
5.3 Picture 1

Signs of fungi growth is present on the floor system in crawlspace in several areas. We did not inspect, test or determine if this growth is or is not a health hazard. The underlying cause is moisture. I recommend you contact a mold inspector or expert for investigation or correction if needed.

Signs of fungi growth is present on the floor system in crawlspace in several areas. We did not inspect, test or determine if this growth is or is not a health hazard. The underlying cause is moisture. I recommend you contact a mold inspector or expert for investigation or correction if needed.

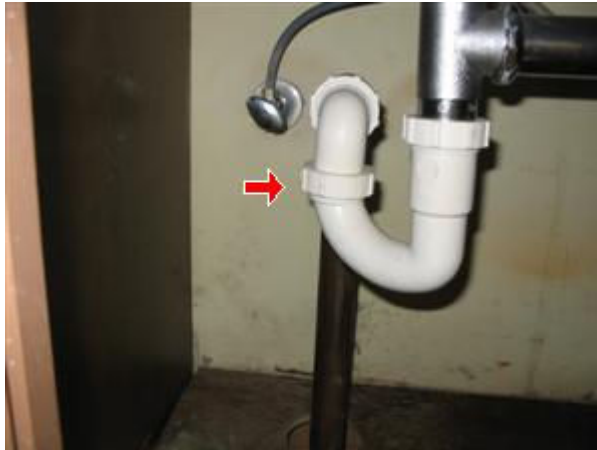
6.0 Picture 1

The waste line has a S-trap, and should be changed to a P-trap and "Auto-vent" at the Kitchen sink. This is not considered up to today's standard. A qualified licensed plumber should repair or correct as needed.

The waste line has a S-trap, and should be changed to a P-trap and "Auto-vent" at the Kitchen sink. This is not considered up to today's standard. A qualified licensed plumber should repair or correct as needed.

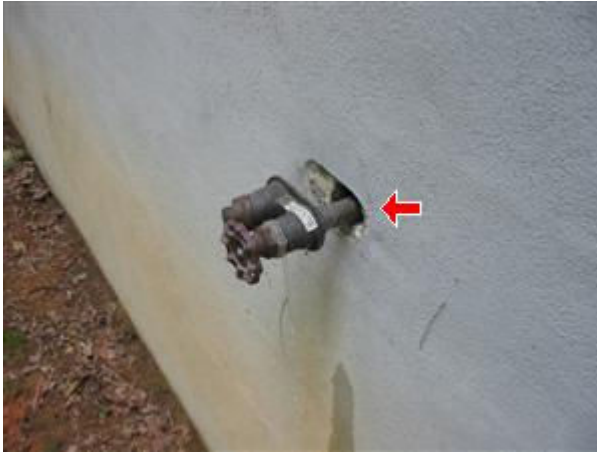
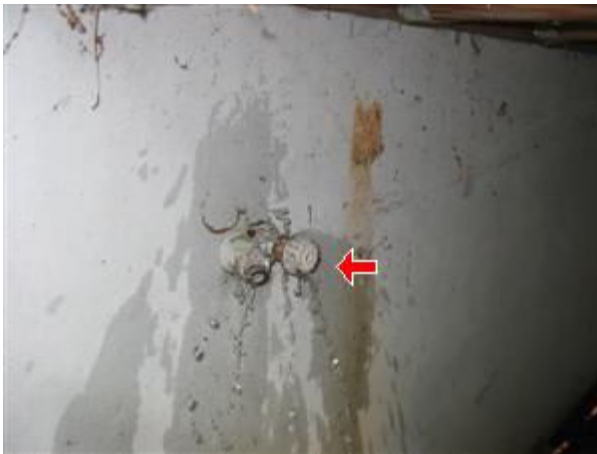
6.1 Picture 1

The outside water faucets are loose, and needs securing to wall and leaks when turned on and leaks at vacuum breaker at the left side (facing front) and right side (facing front). Repairs are needed. A qualified licensed plumber should repair or correct as needed.

The outside water faucets are loose, and needs securing to wall and leaks when turned on and leaks at vacuum breaker at the left side (facing front) and right side (facing front). Repairs are needed. A qualified licensed plumber should repair or correct as needed.

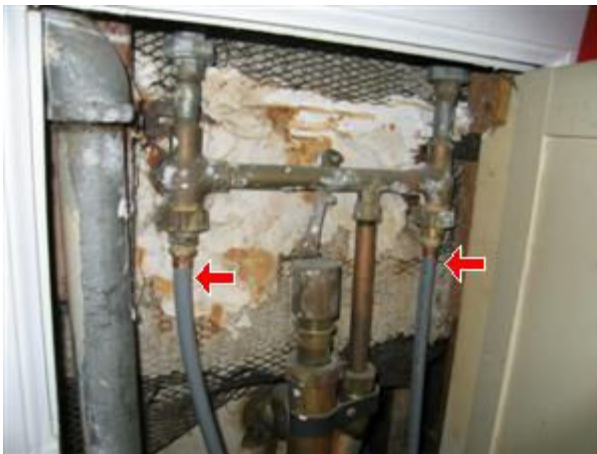
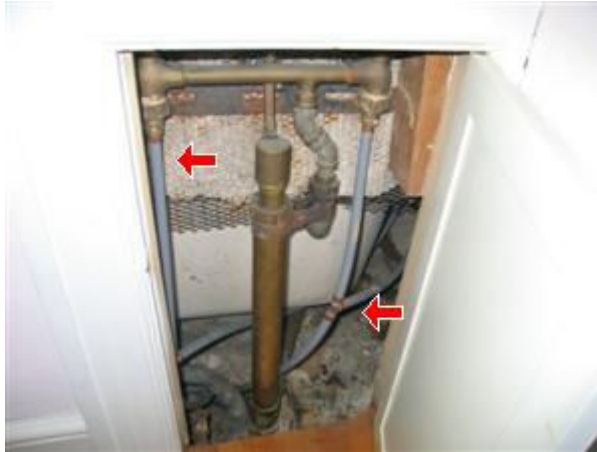
6.1 Picture 3

Polybutylene plastic plumbing supply lines (PB) are installed in the subject house. Polybutylene has been used in this area for many years, but has had a higher than normal failure rate, and is no longer being widely used. Copper and Brass fittings used in later years have apparently reduced the failure rate. This subject house has copper fittings. For further details contact the Consumer Plumbing Recovery center at 1-800-392-7591 or the web at <http://www.pbpipe.com>

Polybutylene plastic plumbing supply lines (PB) are installed in the subject house. Polybutylene has been used in this area for many years, but has had a higher than normal failure rate, and is no longer being widely used. Copper and Brass fittings used in later years have apparently reduced the failure rate. This subject house has copper fittings. For

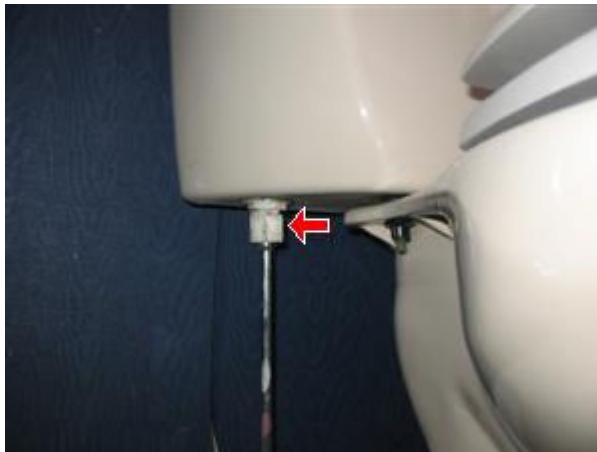
6.1 Picture 5

The water supply line for toilet is leaking at the guest bath. Repairs are needed. A qualified licensed plumber should repair or correct as needed.

The water supply line for toilet is leaking at the guest bath. Repairs are needed. A qualified licensed plumber should repair or correct as needed.

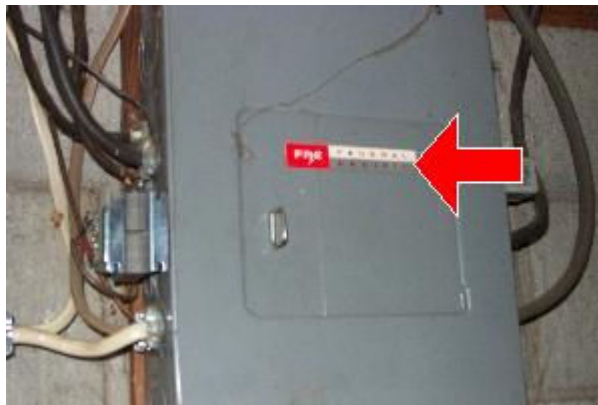
7.2 Picture 1

<input type="checkbox"/>	<input type="checkbox"/>	<input type="checkbox"/>	<input checked="" type="checkbox"/>	7.2 BRANCH CIRCUIT CONDUCTORS, OVERCURRENT DEVICES AND COMPATIBILITY OF THEIR AMPERAGE AND VOLTAGE Branch wire 15 and 20 AMP: Copper Wiring Methods: Romex, Knob and Tube, Not Visible Comments: You have a Federal Pacific panel which is legal, but there is a possibility that the circuit breakers may not trip when shorted possibly causing an electrical hazard. Opinions by licensed electricians on this panel varies between safe and unsafe. I recommend you consult a licensed electrician for an opinion and correct if necessary.
--------------------------	--------------------------	--------------------------	-------------------------------------	---

You have a Federal Pacific panel which is legal, but there is a possibility that the circuit breakers may not trip when shorted possibly causing an electrical hazard. Opinions by licensed electricians on this panel varies between safe and unsafe. I recommend you consult a licensed electrician for an opinion and correct if necessary.

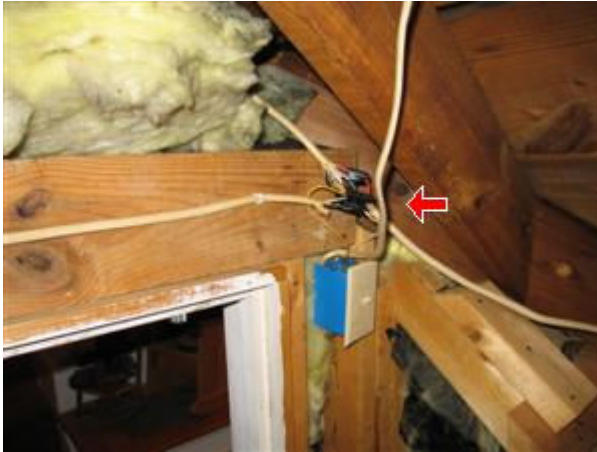
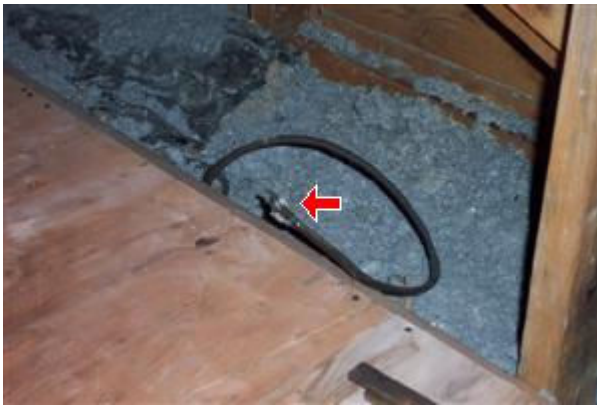
7.3 Picture 1

<input type="checkbox"/>	<input type="checkbox"/>	<input type="checkbox"/>	<input checked="" type="checkbox"/>	7.3 CONNECTED DEVICES AND FIXTURES (Observed from a representative number operation of ceiling fans, lighting fixtures, switches and receptacles located inside the house, garage, and on the dwelling's exterior walls) Comments: One loose wire splice and One loose wire end need placing in boxes with cover-plates within "Five feet" of attic access and above the Guest bath in attic. Electrical issues are considered a hazard until repaired. I recommend a qualified licensed electrician correct.
--------------------------	--------------------------	--------------------------	-------------------------------------	---

One loose wire splice and One loose wire end need placing in boxes with cover-plates within "Five feet" of attic access and above the Guest bath in attic. Electrical issues are considered a hazard until repaired. I recommend a qualified licensed electrician correct.

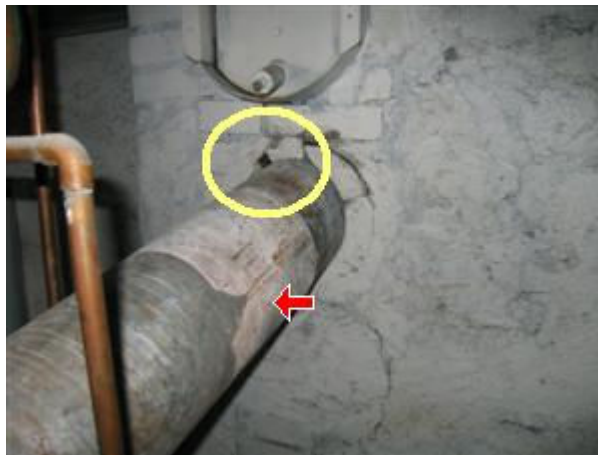
8.5 Picture 1

The vent pipe for oil fired boiler needs mastic sealed around pipe where it enters chimney. There is also a possibility of asbestos on the vent pipe. This is a safety issue and should be repaired. I recommend a qualified licensed heat contractor inspect further and repair as needed.

The vent pipe for oil fired boiler needs mastic sealed around pipe where it enters chimney. There is also a possibility of asbestos on the vent pipe. This is a safety issue and should be repaired. I recommend a qualified licensed heat contractor inspect further and repair as needed.

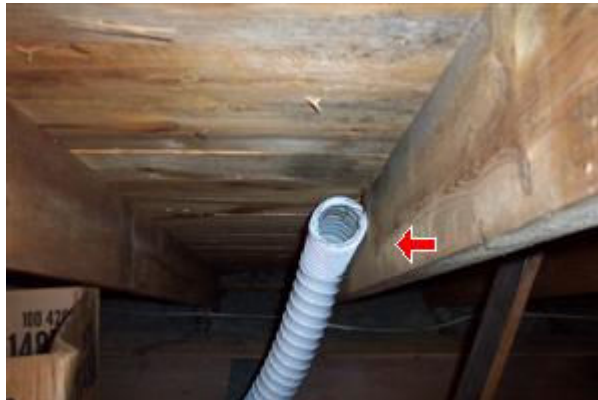
9.4 Picture 1

<input type="checkbox"/>	<input type="checkbox"/>	<input type="checkbox"/>	<input checked="" type="checkbox"/>	9.4 VENTING SYSTEMS (Kitchens, baths and laundry) Exhaust Fans: Fan Dryer Power Source: 220 Electric Dryer Vent: PVC Rigid Comments: The Exhaust fan does not vent to outside at the guest bath. Vent pipes should terminate outside and not in the attic. Many homes have their vent pipe poised at the roof vent such as yours. It is up to you to determine whether or not this is a concern or needs further consideration from a general contractor. A qualified contractor should inspect and repair as needed.
--------------------------	--------------------------	--------------------------	-------------------------------------	--

The Exhaust fan does not vent to outside at the guest bath. Vent pipes should terminate outside and not in the attic. Many homes have their vent pipe poised at the roof vent such as yours. It is up to you to determine whether or not this is a concern or needs further consideration from a general contractor. A qualified contractor should inspect and repair as needed.
